Vessel NATX-32000

External Inspection

Pressure Vessel Inspection Report – **DRAFT REPORT**

In accordance with API 510

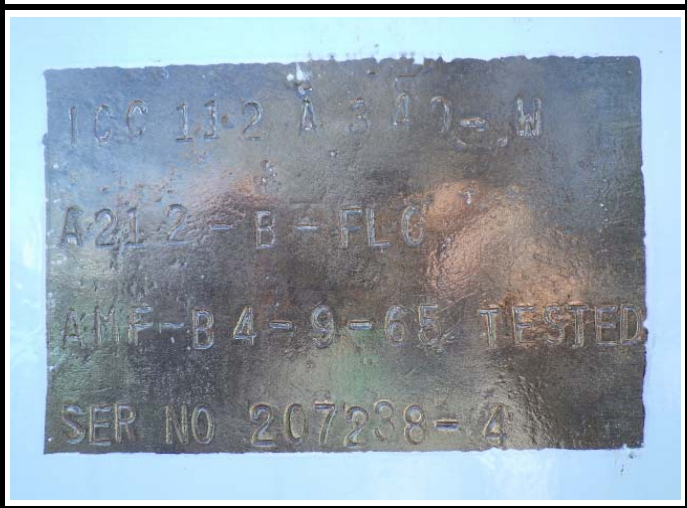
Original Data Stampings on North Head	View of Underside of Shell

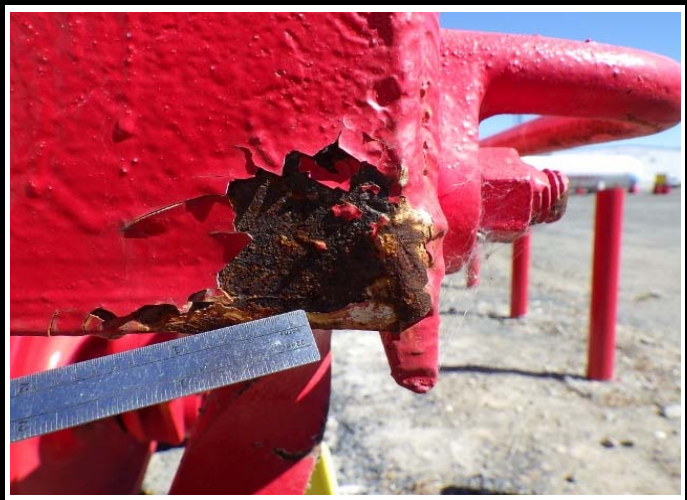
Coating Failure on Grating Support Frame South	Prior Active Corrosion

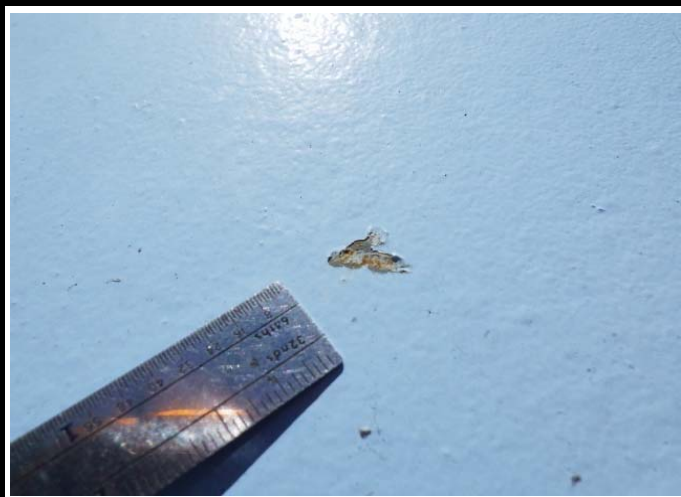
Coating Failure North Head	Shell Coating Failure Typical

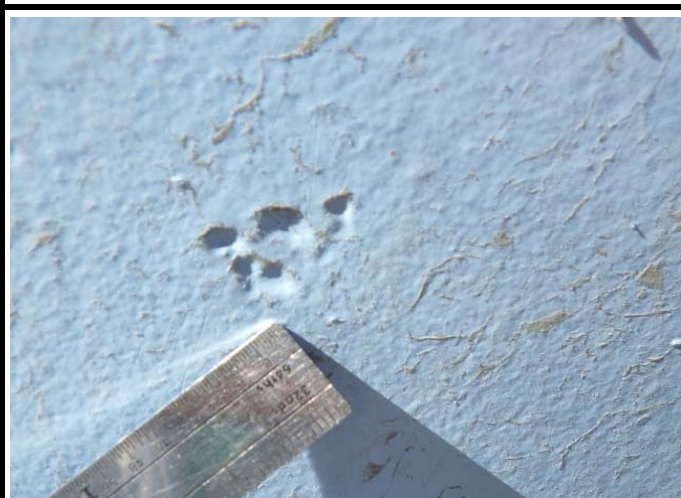
Prior Pitting on North Head	Mechanical Scrape on North Head

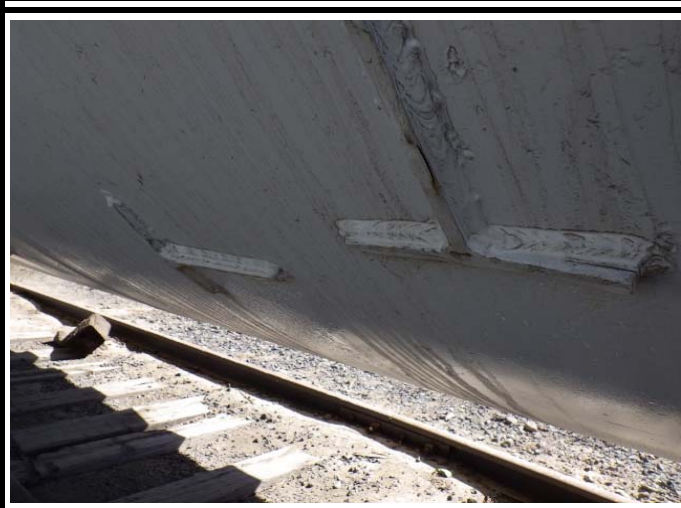
Old Shell Attachments	Mechanical Scrap in Shell

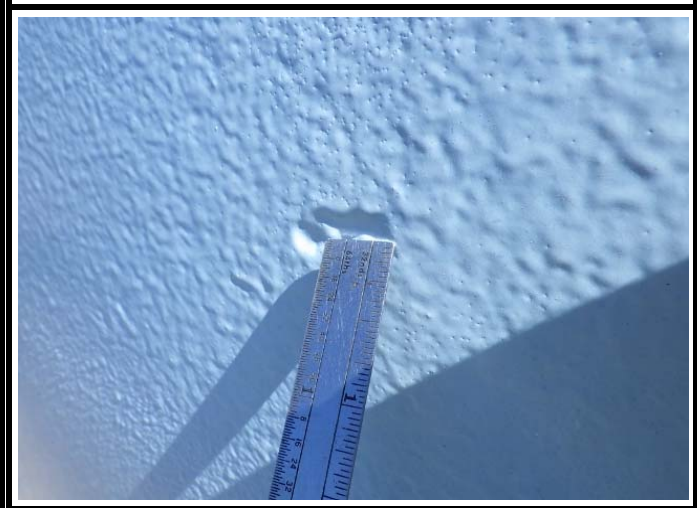
North Head Step Grating	Prior Corrosion on South Head

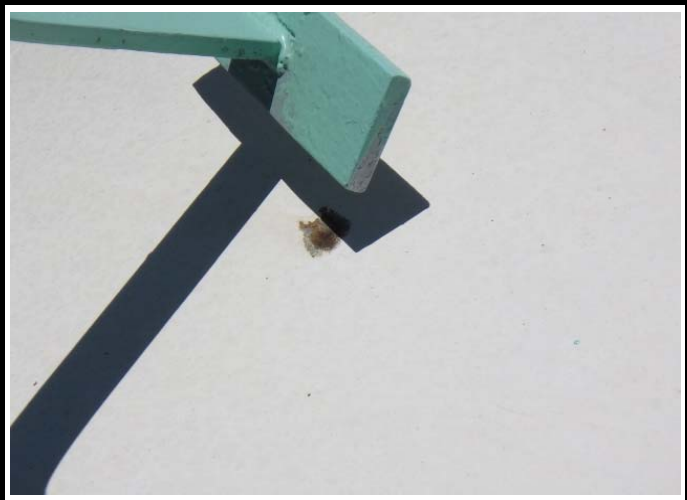
Coating Wear at Platform Contact Point	Top Walkway Overview
